**C-130 Broad Area Review (BAR)**

**ADDENDUM**

**King 56 Salvage**

25 August 1998 Addendum  
to the 15 January 1998 Report

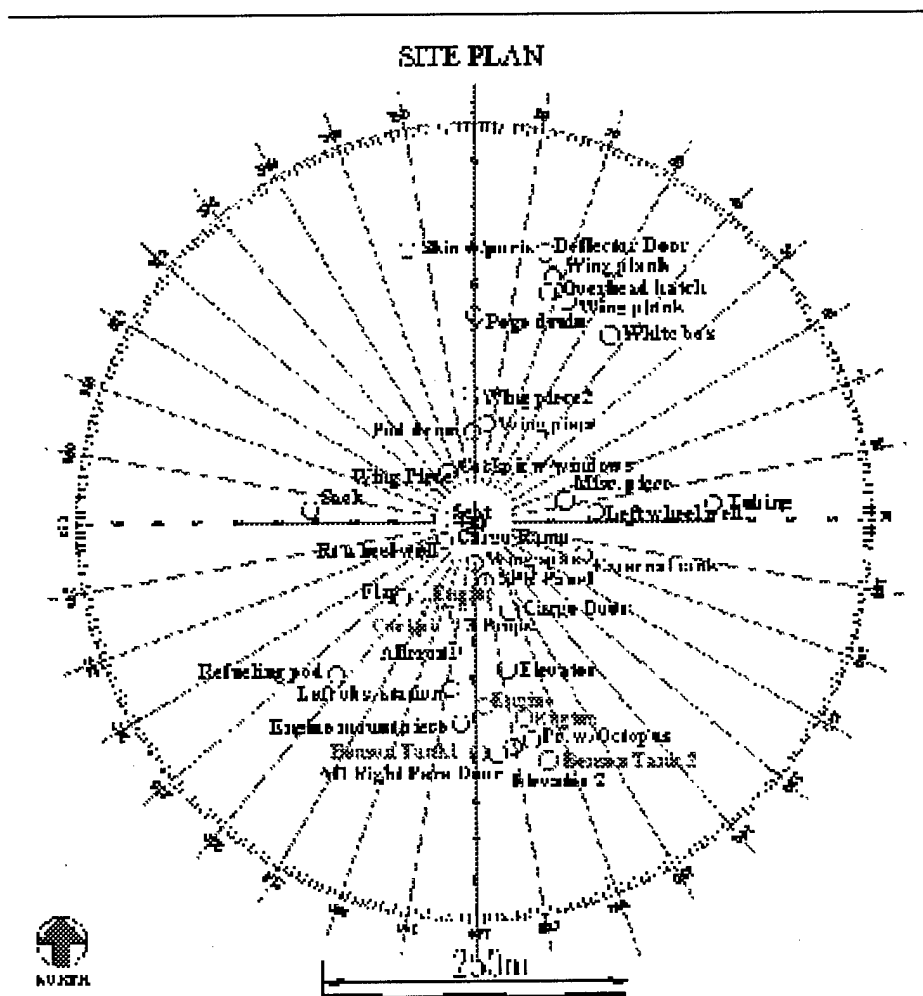
### Figure 1-1

**1.3 Locating the Wreckage:** The location of the main body of wreckage (debris field) was certain but the location of a key piece of wreckage (approximately 55' of the wing) was uncertain. Shortly after King 56 crashed, the U.S. Coast Guard Cutter Buttonwood made an attempt to recover the wing. Despite valiant recovery efforts, the wing was lost. A considerable effort went into reviewing the Buttonwood's situation report and subsequently the detailed logs to define search areas after projecting a last known position for the wing. The M/V Independence found the main debris field at its expected location at a depth of 5,300 feet. The M/V Auriga conducted a search for the wing and finally located it at a depth of 3,200 feet approximately 13 miles from the main debris field. Figures 1-1 and 1-2 show the main debris field and location of the wing to main debris field.

US AIR FORCE C-130 "KING 56" DEBRIS RECOVERY

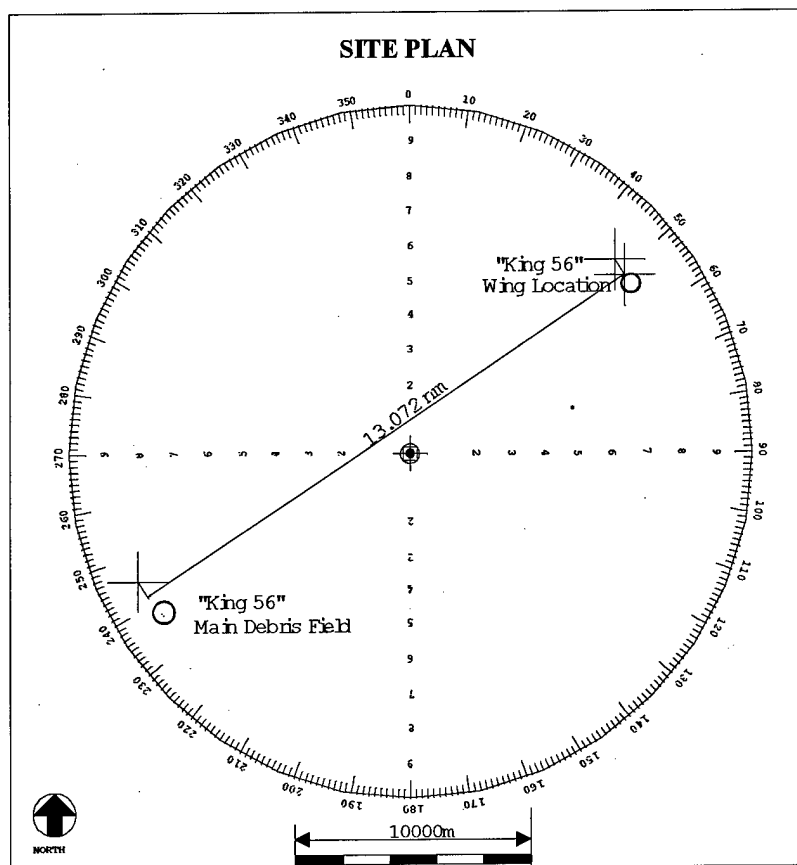
Figure 1-2

US AIR FORCE C-130 "KING 56" DEBRIS RECOVERY

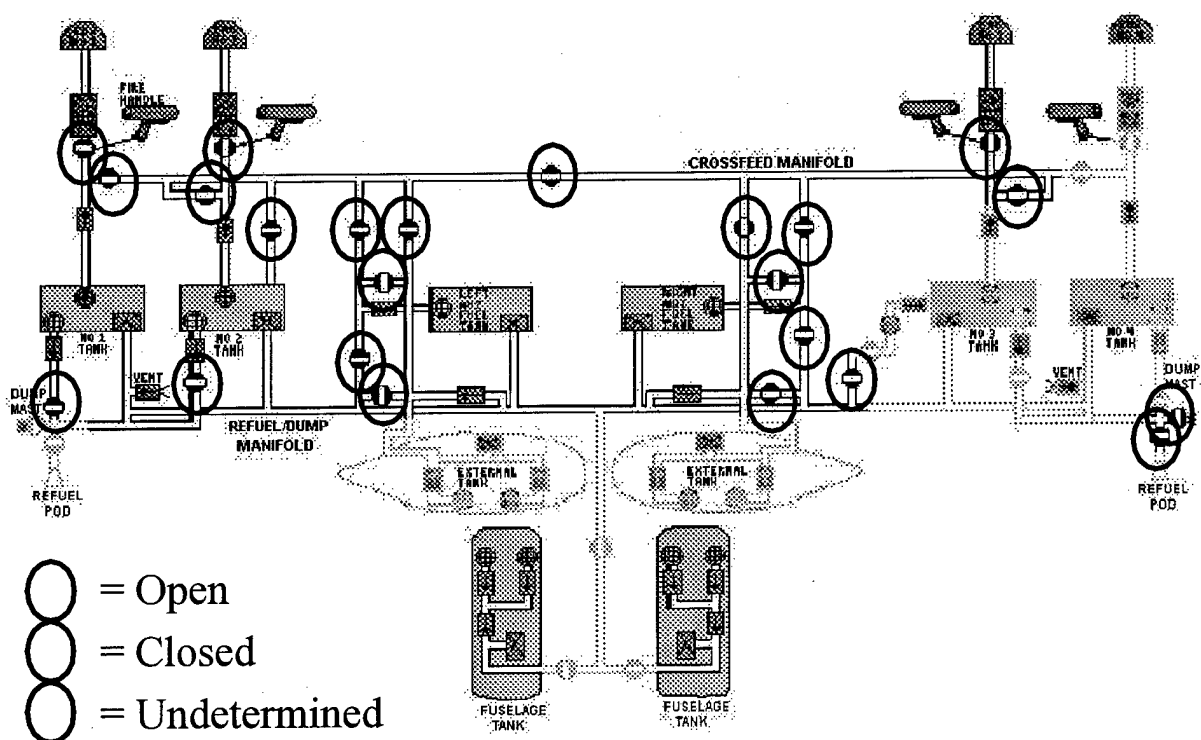
Valve Positions from Recovered Wreckage

**2.1.2 Valve Positions:** Valve positions were all carefully documented. They were visually inspected and physically verified. The position of fuel valves are important because, in the event of a complete electrical failure, they retain their final powered position. Specifically, the fuel system control valves are motor operated and receive power from the essential DC bus. Essential DC power was lost when the last engine driven generator ceased to supply power to the essential AC bus (The essential DC bus receives power from the essential AC bus through two transformer rectifier units). Therefore, these valve positions reflect their position when the last engine flamed out. If the final powered position of enough valves is determined, then it is probable that the tank supplying fuel when the flameouts occurred can be determined.

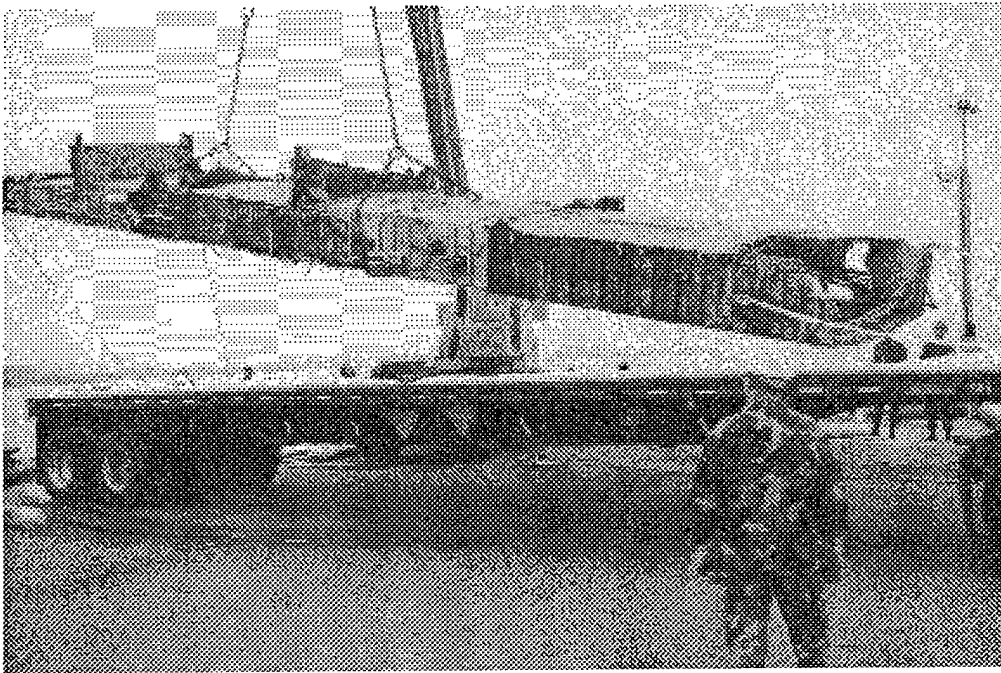
Center Wing Section Being Loaded for Transport
